Engineering Ethics Case Study of Hydroelectric Sayano-Sheshenkaya Accident: Lesson Learned for Malaysian Engineer

M. F. Sulaima, M. N. Othman, M. H. Jali, M. K. Nor, N. H. Shamsudin

Faculty of Electrical Engineering, Universiti Teknikal Malaysia Melaka, Malaysia Faculty of Electrical Engineering, Universiti Teknikal Malaysia Melaka, Malaysia Faculty of Electrical Engineering, Universiti Teknikal Malaysia Melaka, Malaysia Faculty of Electronic and Computer Eng, Universiti Teknikal Malaysia Melaka, Malaysia Faculty of Electrical Engineering, Universiti Teknikal Malaysia Melaka, Malaysia

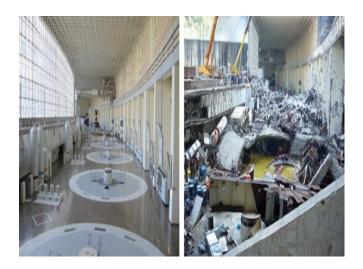
First, the 1,860-ton turbine cover was blown off, leaving the unit 2 turbine in its pit with no turbine mountings. In an instant, the water head pressure from the dam immediately ejected the turbine rotor from the pit. The rotor is continuing to spin as it flew across the turbine gallery, destroyed everything and everyone in its path

As the turbine gallery filled with water, Unit 7 and 9 turbines continued to operate when their safety shutdown systems failed to trip. Eventually, the turbines were submerged, causing extensive damage to equipment and structures.

Figure 5. The destruction of the turbine, before and after gallery turbine plant.

The accident was started by the explosion of the turbine 2. The explosion and the destruction of turbine 2, 7 and 9 were probably caused by water column separation in the turbine draft tubes during unit load rejection. Turbine blade had been speeded up to an unsafe level because of the unstable electrical loads that caused the hydraulic transient phenomenon to be happen. Besides, when the turbine blade in this plant want to be adjusted to increase the operating speed above safe levels, it must been done in a good faith. It cannot be done by the operations personnel who were not familiar and do not have any experience in handling the hydraulic transient phenomena.
