An Engineering Ethics Case Study Review: Petrobras P-36 Accident

O. A. A. Ghani^a, M. Z. Kamruzaman^b, M. F. Sulaima^c, M.N. Othman^d
Faculty of Electrical Engineering, Universiti Teknikal Malaysia Melaka, Malaysia

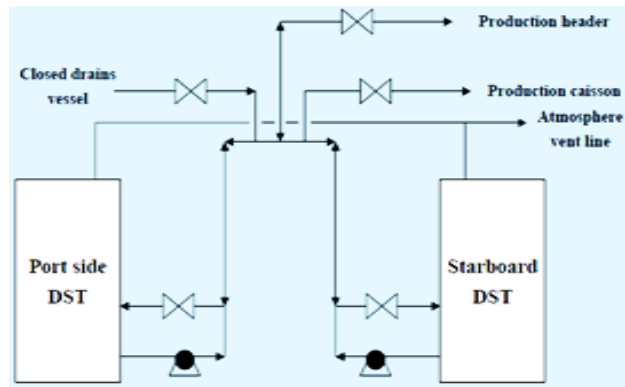
The Fig. 5 and 6 show that the system is in a multi-functional failure, as well as deficiencies in the initial setup which was introduced as a guide [4-5].Due to the delay in the drain pump port emergency drain tank inevitable and clarified the fluid flow takes approximately 1 hour. This fluid can flow through the valve leak emergency drain tank closed inner right side, which, having no secondary protection in place to prevent leakage. After the tank set off water pipes burst and the sea was breaking, flooding has caused seawater pump travel distance becomes shorter. The valve components (still in set design failure) fail in the open position, after the flood of uncontrolled inner pole began to flow freely. Despite the failure to make a choice set is not necessarily yes presumed guilty , also place control without any advance preparation system for controlling the flow of sea water when the pump is running and has are short circuited from the flood. In addition, the failure of watertight dampers in the ventilation system works add to the effects of more severe flooding.

Fig. 5 Condition of component failure

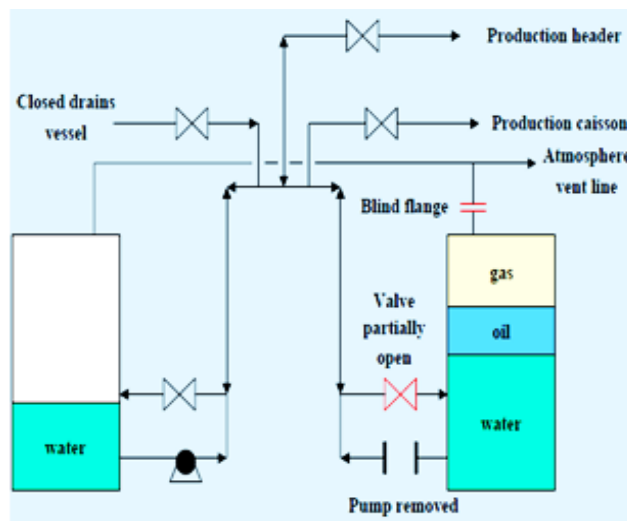
Fig. 6 Condition of valve failure
