## **Case Study of Engineering Ethics toward Natural Gas Pipeline Leaking: An Analysis through Solving Technique**

**M. F. Sulaima, M. K. M. Zambri, M. N. Othman, M. N. M. Nasir, M. H. Jali,  
Z. H. Bohari, W. M. Bukhari, T. A. Izuddin, M. K. Nor**

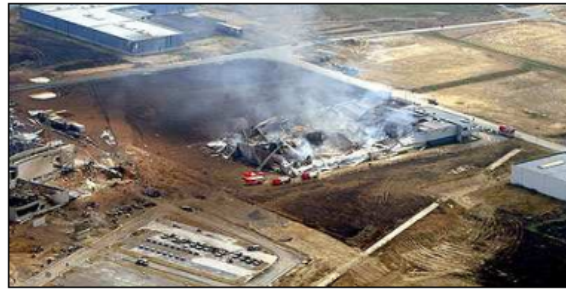
In property damage, an industrial zone of 200m radius is totally destroyed. Besides, a large number of roof and car was damaged and many agricultural fields are burned. The loss caused by the accident is estimated 100 million euros which calculated in October 2004.

**Figure. 1.200m radius from the pipeline is totally destroyed [2].**

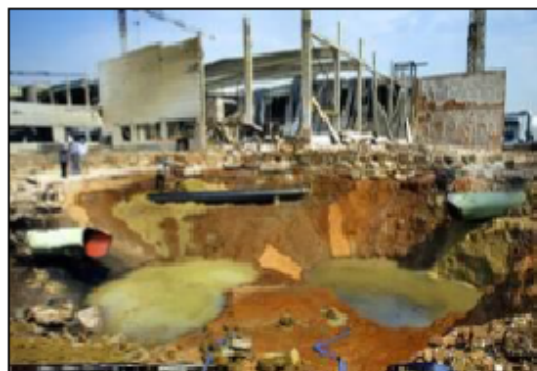
Investigation was conducted in order to find the root cause of the accident. However, the questions remain unanswered. Experts and investigator only found out the gas explosion is caused by pipe leaking. Hence, experts and investigators listed few reasons that cause the pipe leaking. The first cause of the tragedy is safety regulations are not being observed due to the deadlines given by the manager is too short. These lead to some firms on the site do not observe the danger zone designed to prevent heavy machinery being placed over the pipelines. As the heavy machinery placed above the pipelines, there are potential mechanical aggressions that may weakened the pipe wall. Besides, heavy rain and large machinery will cause soil erosion; this explained some pipes are not 1.1m beneath the surface [3].

**Figure. 2.Explosion happened due to pipe leaking [3].**
