## External Patch Fillet Repair for Sulphur Recovery Unit of Petroleum Refinery Plant

In this project, the method of repairing the SRU wall due to thinning is presented. Routine inspection detected irregularities on the part of the SRU reheater external shell wall. In order to avoid future unplanned operation disruption, the repair was performed according to codes and standards.

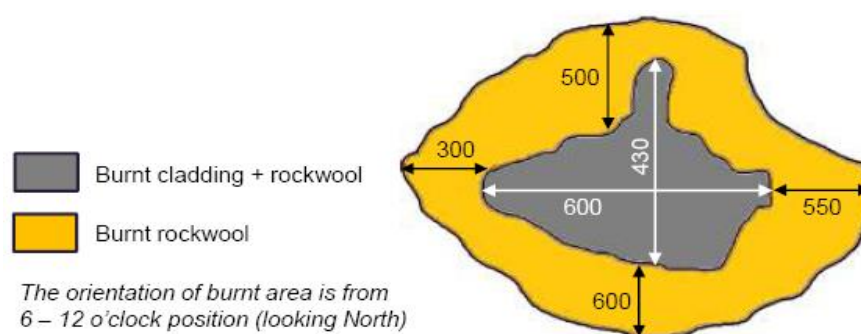
The SuperClaus (RC) Reheater was found with a localized burning mark in the insulation cladding, rockwool and shell wall. The damaged mark is illustrated in Figure 1. The shell wall found with dark colour, which is suspected due to the internal localized fire. It is a well-known fact that for any fire ignition to occur, the critical three elements that must be simultaneously present are fuel, oxygen and ignition [9]. Generally, the localized burning in process equipment is mostly due to the presence of pyrophoric iron sulphide in the sour gas refinery process [10-12]. Pyrophoric iron sulphide is formed by the reaction of hydrogen sulphide (>1%) with the rust of carbon steel. The reaction between the two materials forms an iron rust scale on the metal surface. Pyrophoric iron can instantaneously ignite when exposed to air. Therefore, localized burning due to pyrophoric is not uncommon in the sulphur recovery process. The exothermic reaction of pyrophoric iron with air releases a tremendous amount of heat. The amount of heat is enough to make the iron deposits to glow and turns red in colour. Apart from that, the high heat created is adequate to ignite any fuel source and consequently causes fires. The following is the exothermic reaction between iron sulphides that is in contact with air, which can create a high amount of heat:

**Figure 1.** Illustrated Size and Area of Burned Mark Damaged.

The burning also leads to high temperature corrosion damage that is called sulphidation to equipment and piping resulting in higher corrosion rate than the usual experienced due to the formation of  $H_2SO_4$ . Sulphidation is defined as corrosion of carbon steel resulting from their reaction with sulphur compounds in high temperature environments. Furthermore, the presence of hydrogen accelerates corrosion. Sulphur blockage at a 6-inch diameter of air purge line was found during a previous routine inspection. The air purge line is a carbon steel insulated pipe, however, the line is not well insulated due to damaged rockwool insulation. Carbon steel piping is highly susceptible to the formation of pyrophoric iron sulphide. The presence of sulphur blockage suggests that there is insufficient heating causing sulphur to accumulate. Apart from that, the temperature must be above  $138^\circ C$  to prevent an acid dew point corrosion (ADPC). The aim of the design is to pre-heat the purge air before entering SuperClaus process stream to prevent ADPC.

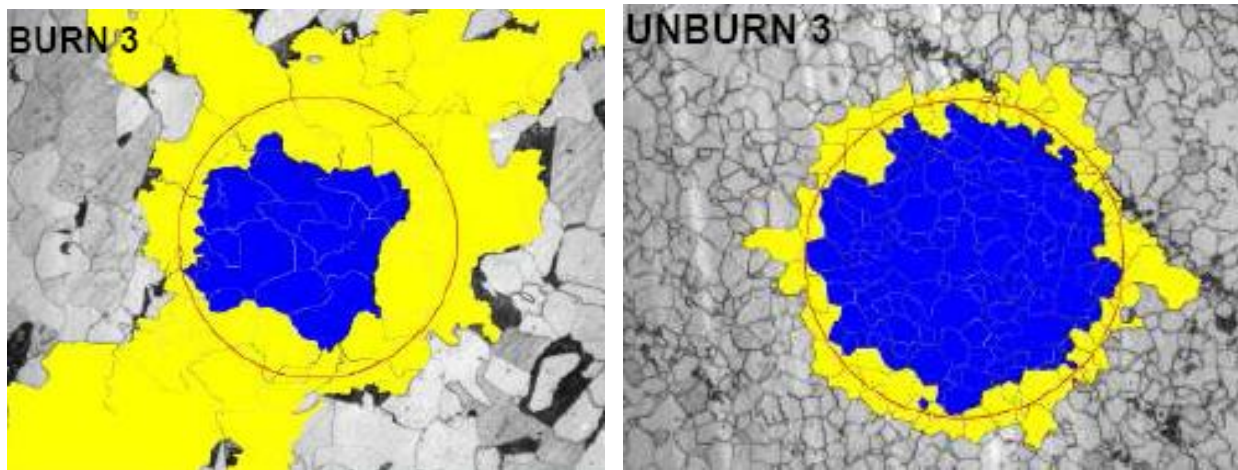
Replica assessment is to identify grain growth measurement (ASTM E112) of the affected area. Six (6) replicated location on the shell wall were taken and evaluated. Three (3) points of the unburned location were located and compared with three (3) points of burned location. The surface replica testing result is categorized as Rating 1 as indicated in Table 1. It was identified that there is a coarser grain at the burned location instead of fine grain as depicted in Figure 2. There is 41% grain growth, indicating steel was likely exposed to above A3 temperature (>930°C) and slow cooling. If the material is exposed to a temperature between 1030°C to 1095°C, then the grain size increased dramatically. The grain growth is a sign of a reduction in strength of the material that might cause the equipment to fail if the similar incident reoccurs.

**Figure 2.** Microstructure grain growth at Location 3.

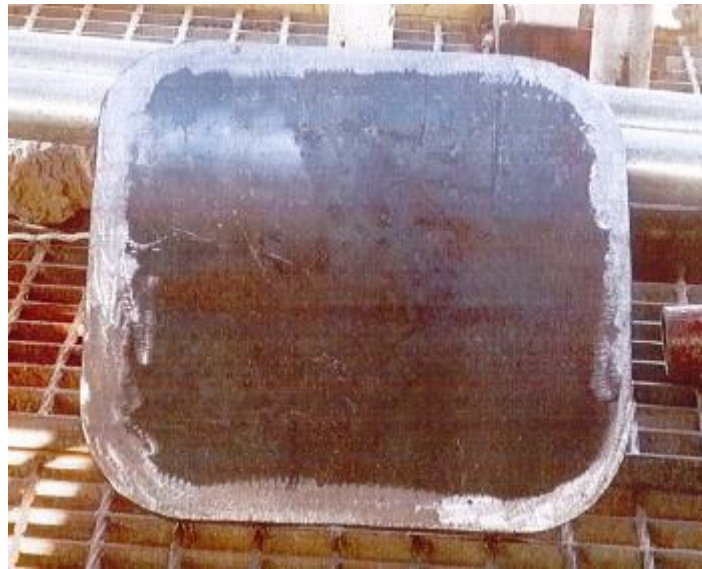
**Figure 5.** Patch plate utilized for the patch fillet.

process and operation. Since the plate thickness used is 15.9 mm which is less than 25 mm, the fillet weld leg should be less than 15.9 mm. The patch plate as shown in Figure 5 must be fitted as tight as possible to the surface to be welded and shall not have more than 5 mm separation between the two faces. If the separation at facing edge is 1.5 mm or greater, the separation value must be added to the eccentricity and the weld parameter should be re-calculated.

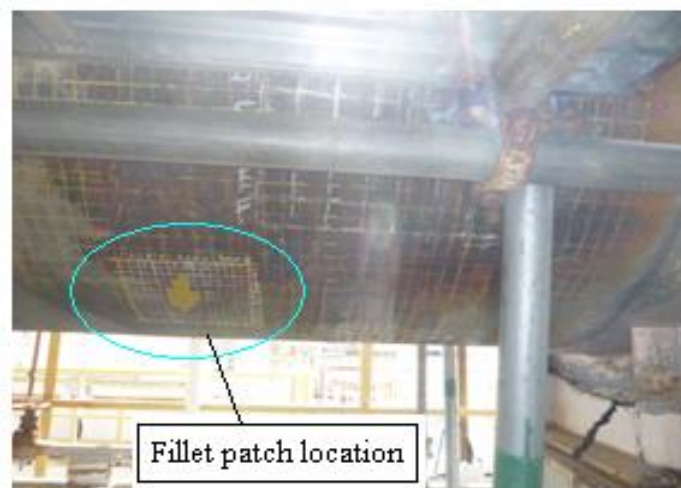
**Figure 6.** Patch fillet location.

The surface area to be welded must be cleared from rust, paint, scale and liquids or other foreign material that could produce lamination or weld defect inclusion of tungsten or porosity. The area of weld zone with a minimum of 40 mm must be cleaned on both sides of the weldment before welding. The fillet patch location is depicted in Figure 6.

After the surface preparation on the affected area, Magnetic Particle Testing (MPT) was performed to ensure the surface is free from any defect or leakage. Dehydrogenation on the working surface at 250°C for 2 hours was performed before fit up after completion of surface preparation and examination tests. Since this equipment is exposed to liquid H<sub>2</sub>S environment, heating pad with insulation is used to avoid hydrogen blistering during welding.

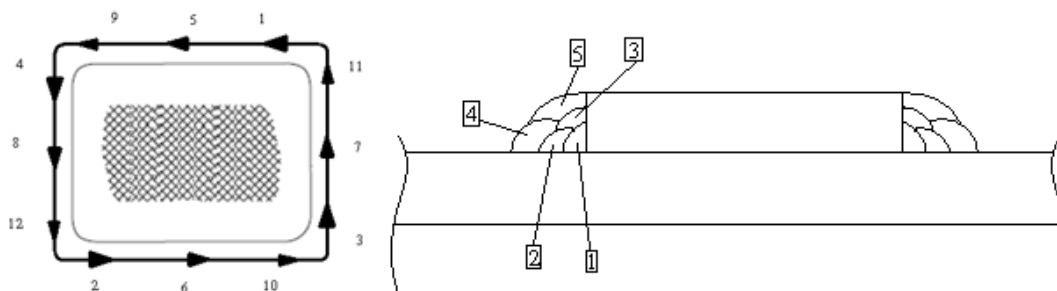
**Figure 7.** Welding sequence.

The patch plate was then fitted up onto the shell wall and it was observed for any separation between plate and shell. The measured maximum separation distance is 5 mm which is acceptable by the standard. Once this critical criterion is satisfied, the plate is then welded on the shell using the welding sequence as shown in Figure 7 to minimize plate distortion. To avoid gas pressure build-up between the patch plate and the pressure component boundary, provisions for venting during the final closure weld or post-weld heat treatment is necessary.

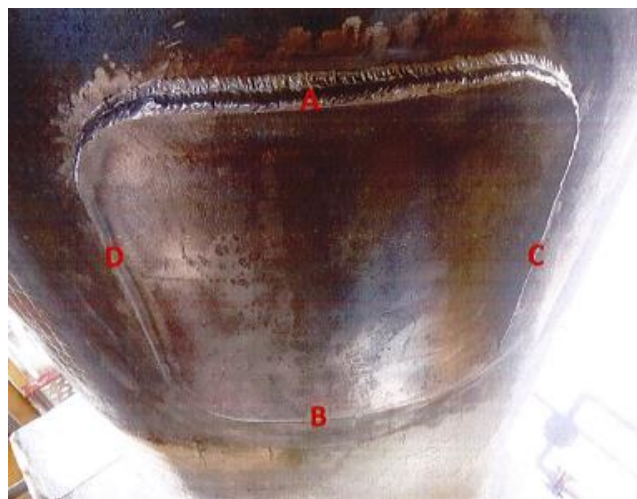
**Figure 8.** Location for Hardness Test after Fillet Weld.

Magnetic Particle Testing (MPT) (root and capping) and hardness testing shall be performed after welding completed by a certified welding inspector to ensure free from any defect (max hardness value for carbon steel 225 HBW). Figure 8 depicts the location of the hardness point. For the final acceptance, the hydro test was performed at the shell side. Shell side test pressure was set at 5.4 kg/cm<sup>2</sup>. The baseline thickness of the patch plate was measured using UT grid scanning. Finally, the patched area was cleaned and painted as per the Petronas Technical Standard (PTS) 15.20.03 was applied (coating system M-9-3).
