INVESTIGATION INTO MAGNETIC DRIVE SEALLESS PUMP FAILURE 3 FLARE GAS RECOVERY UNIT (FGRU)

ABSTRACT

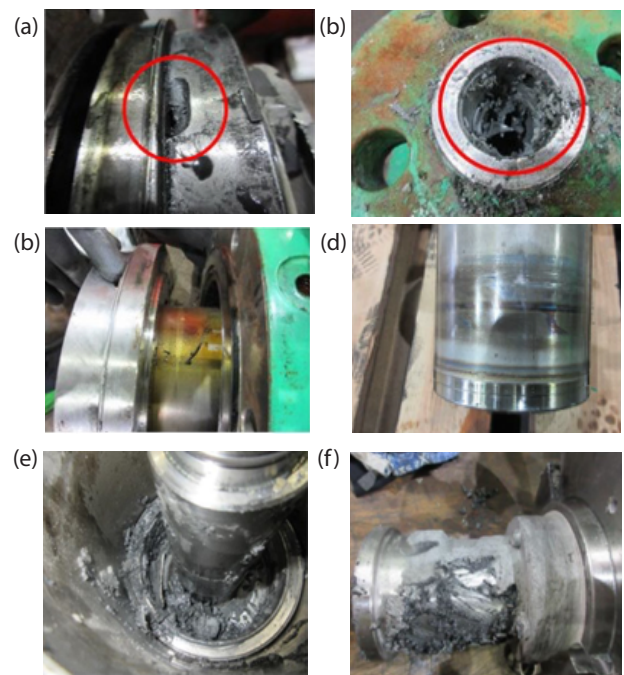
The investigation found that the internal flushing or internal lubrication flow line was clogged with process solid particles. This caused lubricant starvation and loss of cooling to the pump's internal parts. The absence of lubrication had increased friction which caused the mating surfaces to seize. The pump containment shell showed external burnt marks and rubbing, and the bushings were found damaged. In fact, it was supported by the temperature records on the containment shell, which displayed an increase of normal temperature of 60°C to a high of 103°C. Figure 2 shows the extent of damage to the pump's internal parts.

Figure 2 (a) Clogged flushing line (b) Process particles (c),(d) Burn mark on containment shell (e),(f) bushing damages

a duplex filter for the internal flush system to reduce the risk of particle contamination further. Additionally, a differential pressure gauge or indicator must be designed and installed across the duplex filter for routine field operator monitoring. The operator will be notified when particles begin to build up inside the duplex strainer due to this increase in differential pressure. A temperature sensor must be installed in the pump isolation or containment shell for high alarm and high-high trip protection. The pump will trip whenever the temperature exceeds the normal range, preventing further damage. After the investigation and major pump repair were finished, these suggestions were incorporated and implemented in the Fuel Gas Recovery system. The pumps have normally been operating thus far, with neither a single nor any failures recorded.
