Analysis of Tool Performance during Ball-end Milling of Aluminium Alloy 6061-T6

Abstract. This article presents the tool wear mechanism when machining Aluminium alloy 6061-T6 with PVD coated carbide under dry cutting condition. Cutting parameters selected were cutting speed, $V_c = 115-145$ m/min; feed rate $f_z = 0.15-0.2$ mm/tooth and depth of cut, $a_p = 0.5-0.75$ mm. The result showed the tool life of PVD TiAlN ranged from 11 to 97 min. Full factorial approach was employed to exhibit relationship between parameter input and output. From the analysis, cutting speed was found to be the most significant factor for tool performance followed by feed rate and depth of cut. It was also found that most of failure modes occurred were notch wear and flaking near those found near depth of cut line.

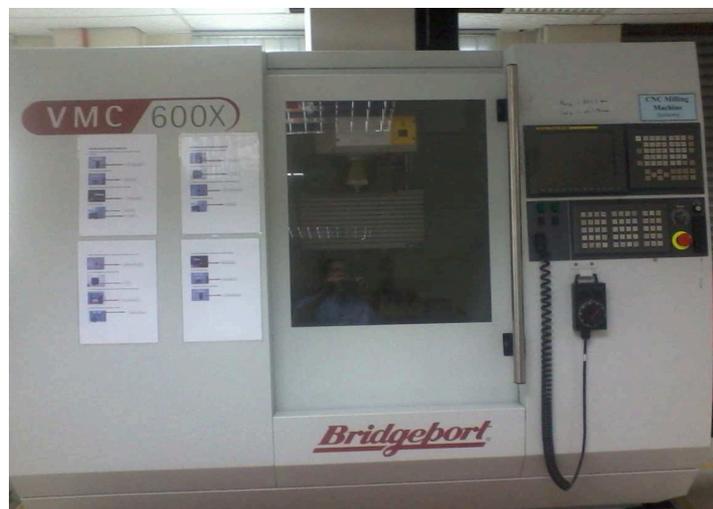
Fig. 1 CNC Milling VMC600X.

Full factorial was used to design experiment to determine the influent of cutting parameter on tool wear. Considering three variable input with two levels, the total experiments are 8 runs (2^3). All experiments were done under the dry and finishing condition. Flank wear was analysed using a two-axis toolmaker's microscope for flank wear measurement. The test will be stopped when the flank wear, V_B reaches 0.3 mm. Worn out tools were further examined microscopic image of tool wear using a scanning electron microscope (SEM) JEOL JSM-638OLA.

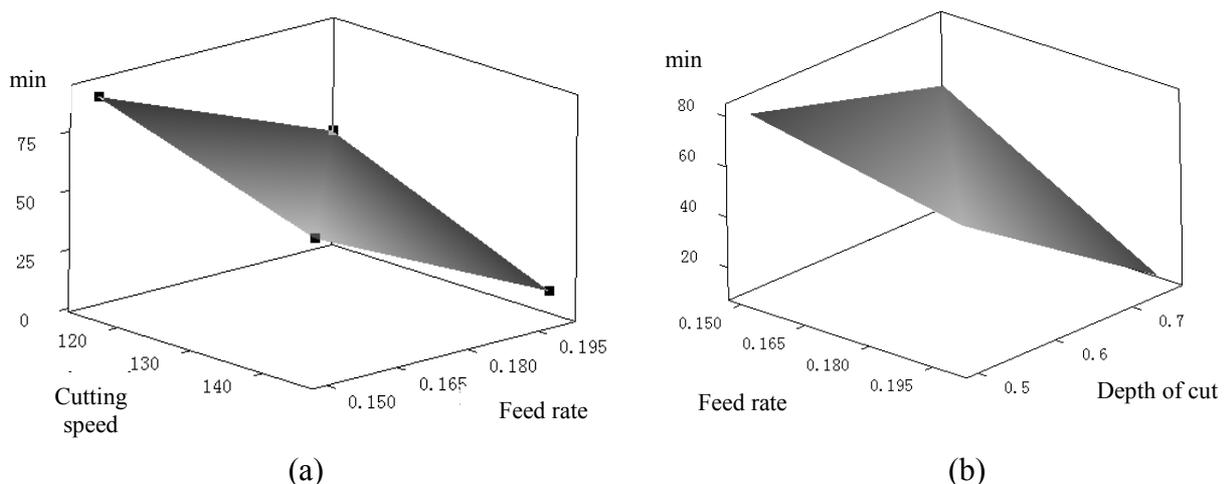
Fig. 2 shows the relationship between cutting parameters (cutting speed, feed rate and depth of cut) and tool life. It consistence with theory with an increase in the cutting speed, the tool life is shorten to a minimum. It was similarly occurred to feed rate and depth of cut. The steep angle of the graph plane shows the most significant of each factor contribute to tool life. It was agreed with F-value from ANOVA that cutting speed was found to be most significant followed by feed rate and depth of cut. The maximum tool life (97 min) can be achieved by the combination of Vc = 115 m / min, fz = 0.15 mm / tooth and ap = 0.5 mm.

Fig. 2 Influence of cutting parameter on flank wear, Vb when milling Aluminium 6061 – T6 with PVD tools; (a) cutting speed against feed rate (b) feed rate against depth of cut.

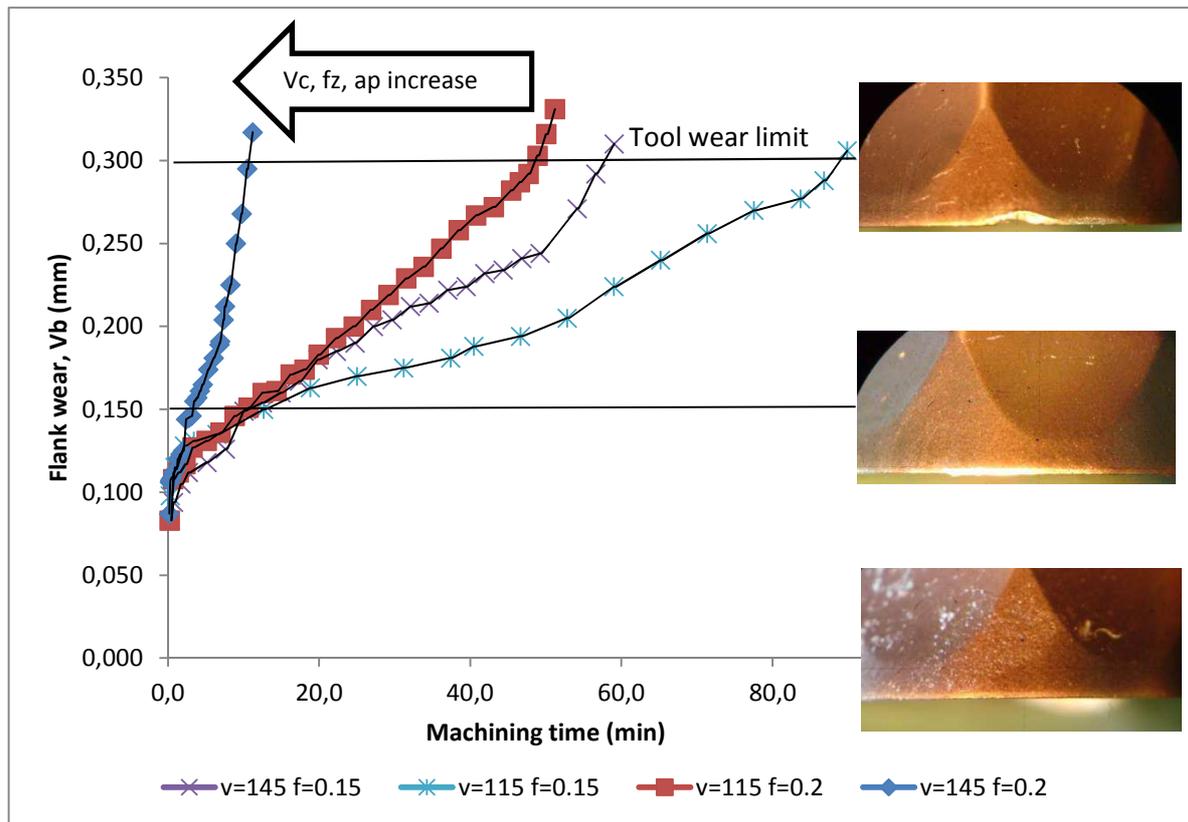
Fig. 3 shows the progress of flank wear thorough machining time. The tool wear pattern observed is typical which accelerate at initial stage, retain constant at steady stage and accelerate back at the end of tool life. The trend shows the total machining time decreased as Vc, fz and ap are increased.

Fig. 3 Tool wear plot in terms of machining time at $a_p = 0.75$ mm.

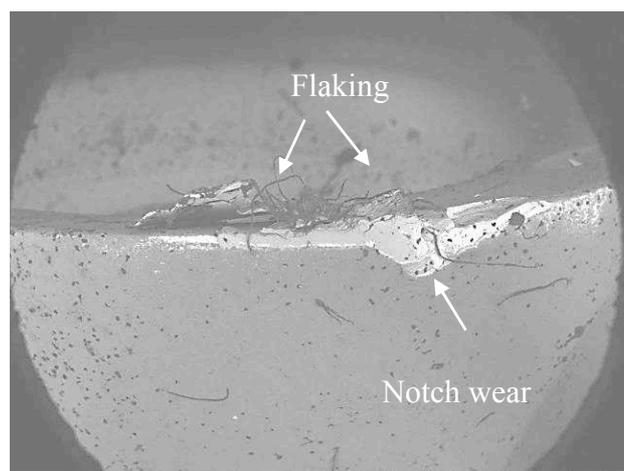
Based on the experiment, it was identified that notch wear and flank wear are the major wear mode during end milling. Notch wear formation as an arc shape normally found at a depth of cut line (Fig. 4). It was incorporated with higher volume of underformed chips to be removed at that region. On the machined surface, the deformation of grain boundary from previous cut causes a hardening effect that worsening the notch wear. Moreover, the interrupted cutting condition of milling process degrade bonding between TiAlN coating and WC substrate, thus cracking and flaking can be found on the rake face due to this cyclic load.

Fig. 4 The main tool failure mode during end milling of Aluminium 6061.

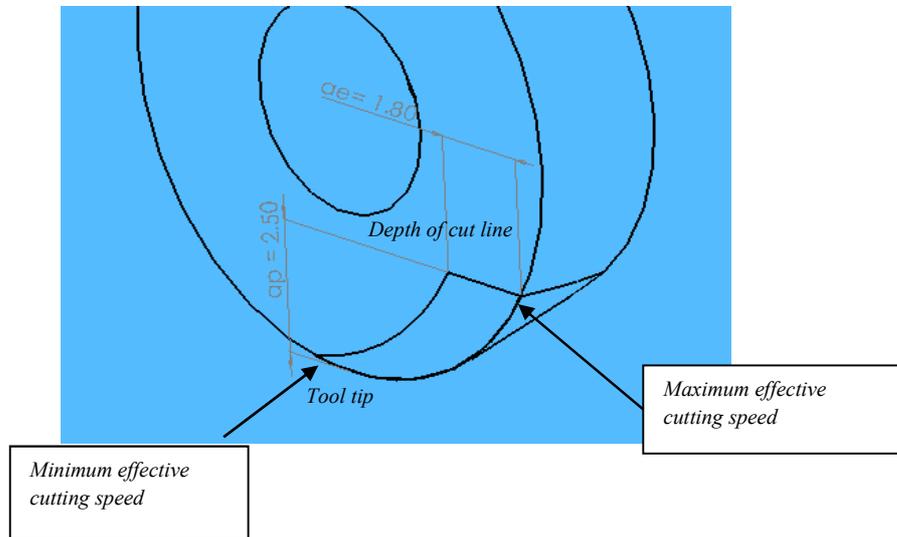
Due to the geometry of the ball nose cutting tool is complex, the effective cutting speed, $V_{c_{eff}}$ is changed at every depth of the cutting tool (Fig. 5). The effective cutting speed increases as the location close to the depth of cut line. It relates to the cutter radius that varied from the tool tip to depth of cut line. Fig. 6 shows the flank wear occurred on the cutting edge. The formation of flank wear is linearly, not uniform identified along cutting edge. The maximum flank wear was found at a

depth of cut zone as a conjunction with the maximum effective cutting speed. Therefore the abrasive wear occurred aggressively in this region. This was likely the maximum temperature generated at the vicinity of depth of cut line due to the maximum volume of material deformation and abrasion. The high temperature is then softening cutting tool. Cracking on cutting edge accelerates tool failure catastrophically.

Fig. 5 Effective cutting speed, $V_{c_{eff}}$ at different tool depth.

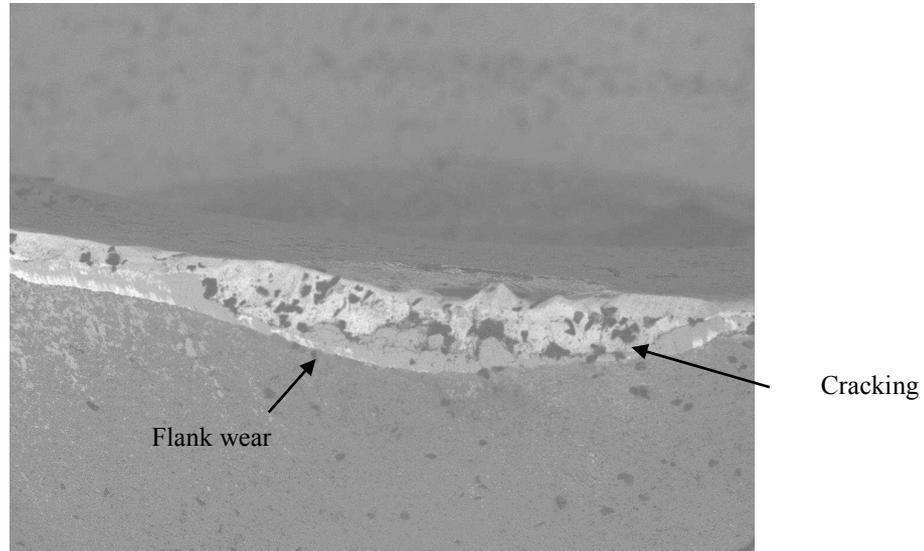
Fig. 6 SEM image of flank wear on cutting edge with the magnification of 140 X at $V_c = 145$ m/min, $f_z = 0.15$ mm/tooth, $a_p = 0.75$ mm.
