## Temperature Data Acquisition for Material Performance of Instrument Panel (IP) in Automotive Applications

**Keywords:** *Temperature, Thermal, Material, Instrument Panel, Automotive*

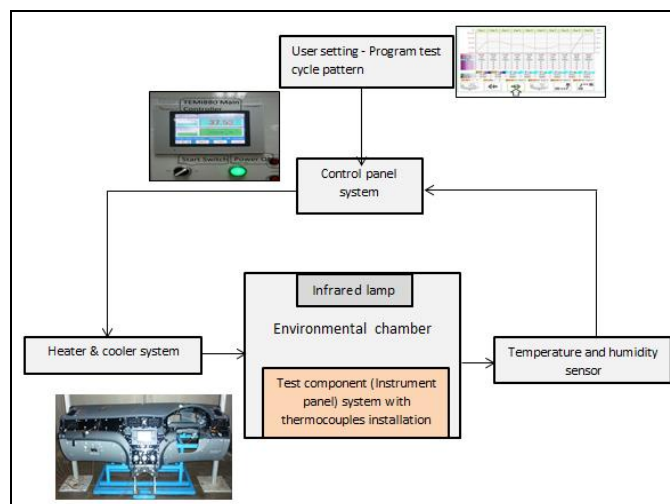
**Figure 1.** Block diagram of the heat cycle test in the laboratory condition.

The temperature achieved on the component surface is recorded using a data logger to obtain the temperature performance during the experiment. The block diagram of the heat cycle test in the laboratory condition is illustrated in Figure 1. Once the test setup is completed, the test commenced with the test cycle as shown in Figure 2. One cycle consists of 24 hours and is set to run for a total of 3 cycles. Daily inspection is conducted only for visual observation to detect any failure at the earlier stage.

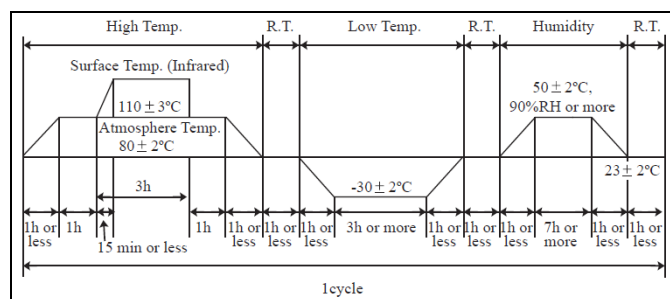
**Figure 2.** Hot, cold and humidity test cycle (1 cycle).

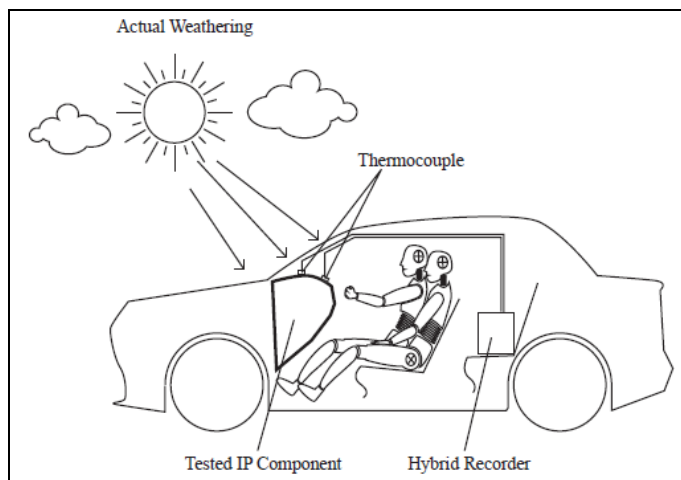
**Figure 3.** Schematic diagram of the test setup during thermal test in field test.

The setup is similar to the experimental works in the laboratory condition, but this work is conducted using a complete build-up vehicle and moving vehicle. This work was carried out with a total trip of 3 days. This car has been driven towards South Malaysia from PROTON Shah Alam to Johor Bharu and then back to the origin. The road choice is not so important since the main purpose of this activity is only to collect the random temperature data in Malaysia while the car is moving. The inspection of the vehicle was conducted to check for any defects or functional problems before running the vehicle. The thermocouple (transducer type) was attached to the components to record and monitor the temperature acquisition. The thermocouple was installed on a component similar to the thermal test in section 2.1.

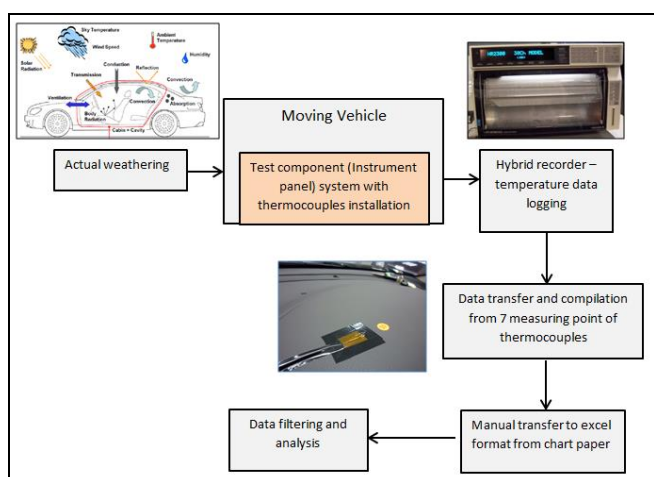
**Figure 4.** Block diagram for temperature data acquisition for thermal test in field test.

In this work, the vehicle speed was about 80 to 100 km/hour and the mileage is about 1025.2 km. Details of routes during this activity is shown in Table 2. . The outside temperature and humidity were measured using a hygrometer and recorded at each checkpoint. The temperature data acquisition on the component was recorded using Yokogawa Hybrid Recorder HR 2300 system connected to a laptop computer. All data are acquired in a moving car with air-conditioned at a set temperature of 18 °C to 25 °C. The total passenger inside each vehicle is 2 persons. The schematic diagram of the test setup during a thermal test in field test is shown in Figure 3. The temperature acquisition was recorded every hour starting from 10 am until 9 pm. The block diagram of the temperature data acquisition for the thermal test in the field test is shown in Figure 4.

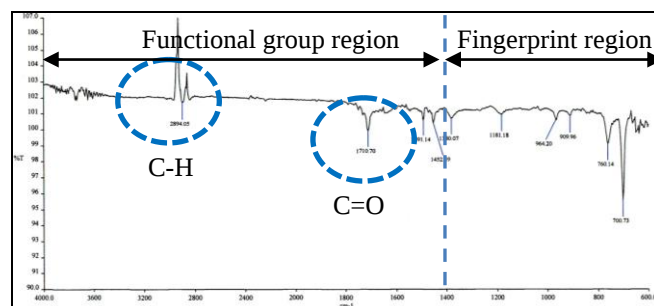
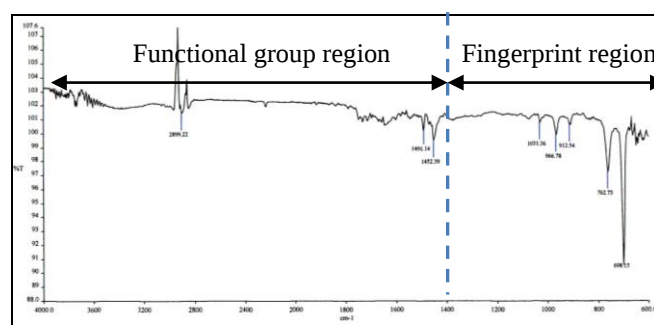
**Figure 5 (a).** FTIR spectrum for P321A air outlet and switch center (ABS material) for tested component.

**Figure 5 (b)** FTIR spectrum for P321A air outlet and switch center (ABS material) for virgin component.

The result of the FTIR spectrum that have been done for P321A air outlet and switch center (ABS material) of tested and virgin components are shown in Figure 5(a) and 5(b), respectively. From these two graphs, the FTIR spectrum was compared to determine whether the material used is similar between tested and virgin component. Based on the result, both components have shown almost the similar spectrum in the fingerprint and functional group region. From here, it is demonstrated that both components are using the similar material grade of ABS 777D. It can be seen that the spectrum contains C-H molecular structure at the functional group region which match with ABS

chemical formula  $(C_8H_8.C_4H_6.C_3H_3N)_n$ . However, there is a formation of carbonyl group  $(C=O)$  for tested components and this behavior might be contributed from the thermo-oxidative degradation after the thermal test.

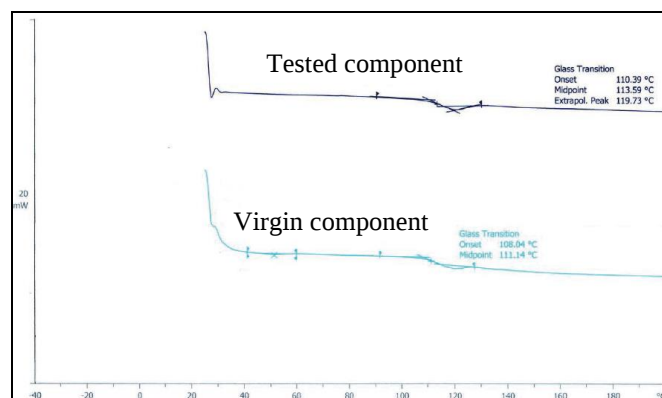
**Figure 6.** DSC curve for the air outlet and switch center (ABS material) for tested and virgin component.

The result of the DSC curve that has been done for the air outlet and switch center (ABS material) is shown in Figure 6. When comparing the DSC curve between tested and virgin component, the material obtained almost the same glass transition temperature with value of 110.39 °C and 108.4 °C, respectively. This result also indicates that both materials are below the heat deflection temperature (128 °C). However, it can be seen the slight increment of about 1.83 % for tested component compared to virgin component. This phenomenon might be due to the polymer molecular has changed after the thermal test.

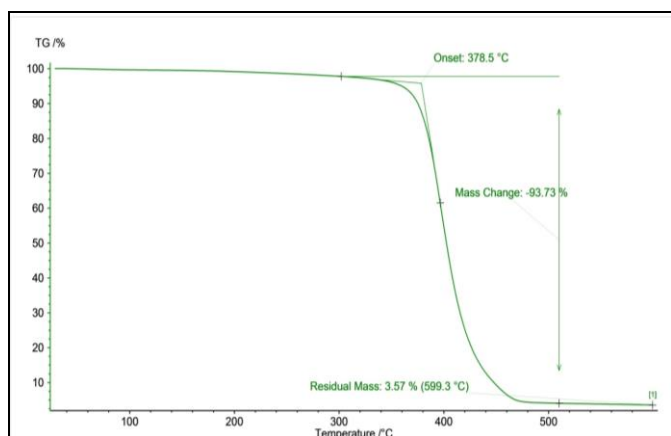
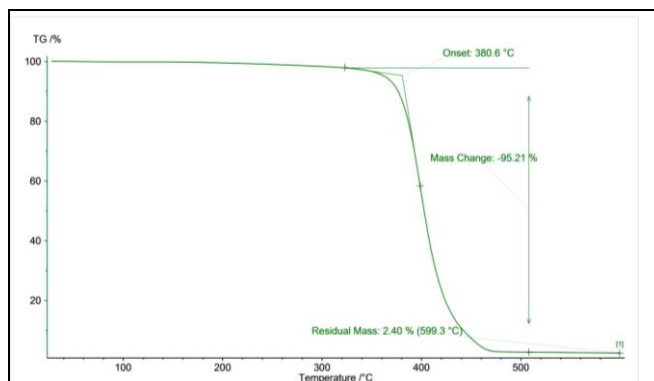
**Figure 7(a).** TGA graph for the air outlet and switch center (ABS material) for tested component.

**Figure 7(b).** TGA graph for the air outlet and switch center (ABS material) for virgin component

In this study, this technique is used to detect traces of additional compound/additives. The result of the TGA analysis that for the air outlet and switch center (ABS material) using tested and virgin components is shown in Figures 7 (a) and (b), respectively. From here, the result has been compared to determine if the material used for tested and virgin component is the same. Based on both graphs, the mass change for tested components is 93.73 %, while for virgin component is 95.21%. It was revealed that both components are using the similar material grade without detection of any recycled material. If the material contains recycled material, the value of the mass change might increase due to presence of foreign materials.

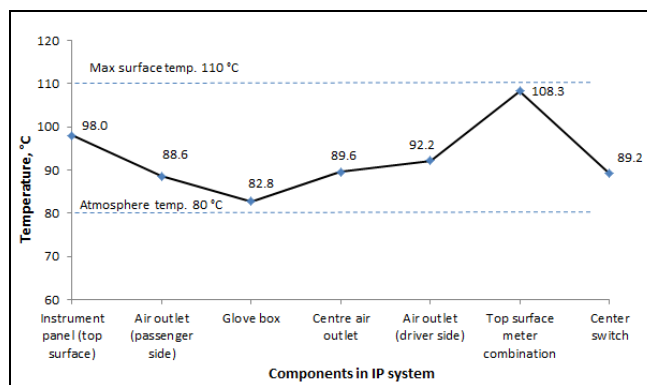
**Figure 8.** Maximum temperature achieved at component on IP system during infrared exposure heat cycle test.

Figure 8 shows the highest maximum temperature achieved on the cover meter combination and IP top surface with a temperature of 108.3 °C and 98 °C, respectively. Meanwhile, the lowest maximum temperature achieved on the glove box with 82.8 °C. This is due to the component being located at the lowest position in the IP system. For another component, the air outlet at the passenger side and centre air outlet exhibited the maximum temperature of 88.6°C and 89.6 °C, respectively. Other than that, the air outlet at the driver's side achieved the maximum temperature of 92.2 °C and the centre switch of 89.2 °C. From all this data, it can be demonstrated that the maximum temperature achieved at each component is below the maximum surface temperature of  $110 \pm 3$  °C and above the atmosphere temperature of  $80 \pm 2$  °C.

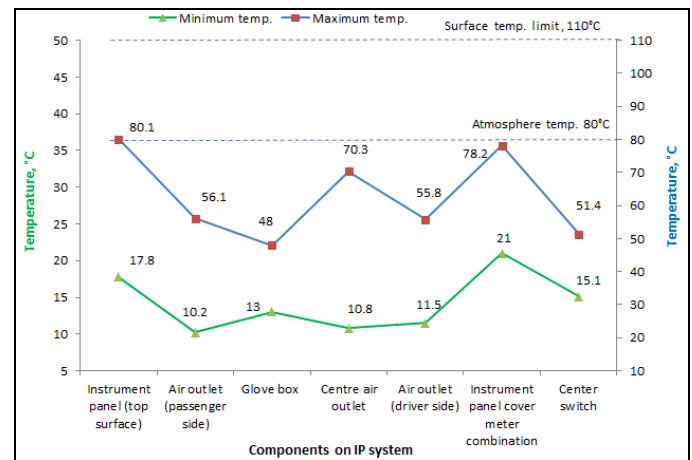
**Figure 9.** Maximum and minimum temperature achieved at each component on IP system during thermal test in field test (actual service).

Based on the graph in Figure 9, the highest maximum temperature on the IP system is the IP top surface and IP cover meter combination with temperature values of 80.1 °C and 78.2 °C, respectively. This result could be explained by the position of these components which are located in the upper area of the IP system. For other components, the maximum temperatures are between 48 °C and 70.3 °C. These temperatures are still below the temperature limit of the PROTON specification (surface temperature of 110°C and atmosphere temperature of 80 °C). It was also below the temperature obtained from the heat cycle test in the laboratory with the temperature ranging between 48 °C and 80.1 °C.

On the other hand, the lowest minimum temperature on the IP system was found in all air outlet areas (air outlet at the passenger side, center and driver side) with a temperature value of 10.2 °C, 10.8 °C and 11.5 °C, respectively. This is correlated well with the source of the

air conditioning system that starts from this component, thus contributing to the lowest temperature in this area. Meanwhile, the minimum temperature achieved in other components is from 13 °C to 21 °C.

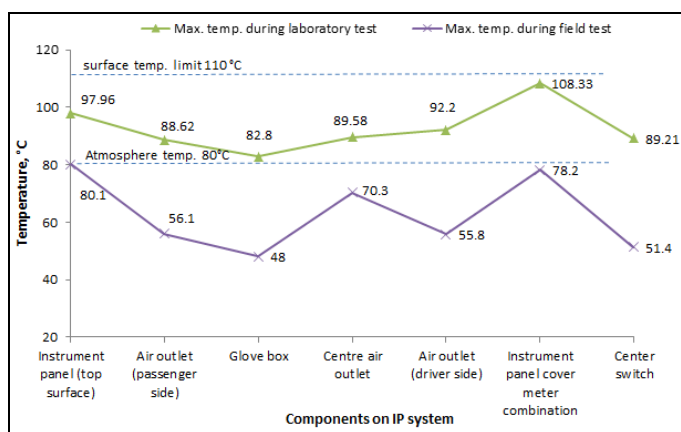
**Figure 10.** Maximum temperature achieved for each component on IP system during laboratory and field test.

The maximum temperature achieved for each component in the IP system between laboratory test and field test was compared and presented in Figure 10. Based on the figure, the maximum temperature was obtained in the range of 82.8 °C to 108.3 °C for the thermal test in laboratory conditions. Meanwhile, for the thermal test in field conditions, the maximum temperature of the components is between 48 °C and 80.1°C. Both temperatures had some fluctuation due to different positions of the component located in the upper or lower area in the IP system. The maximum temperature was achieved at 108.3 °C for the IP meter combination during the laboratory test, while 80.1 °C for IP top surface during the field test. However, both graphs show that the glove box is the component that reaches the lowest temperature during laboratory and field tests with the value of 82.8 °C and 48 °C, respectively.

Overall, it can be seen that the temperature during laboratory tests experienced more consistent values compared to the field test. This is due to the temperature-controlled chamber condition in a laboratory test, while the field test is controlled by natural weathering. Other than that, the maximum temperature achieved during the laboratory test is always higher than the temperature for the field test. This result occurred due to several factors; the component in the laboratory test is exposed directly to the heat environment with a static condition, meanwhile, the component in the field test is conducted using complete vehicle build-up with moving conditions. Other than that, the presence of an air conditioning system during the field test would have changed and reduced the cabin airflow.

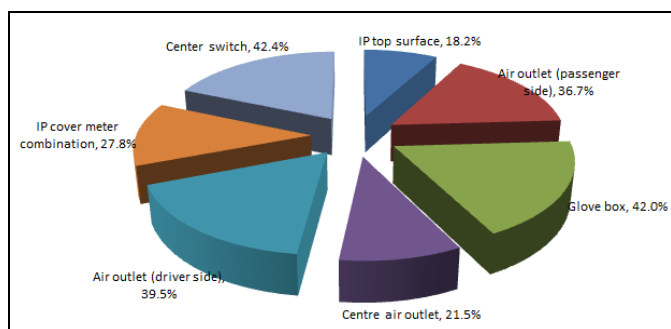
**Figure 11.** Difference of temperature in percentage for each component on IP system between laboratory and field test.

The pie chart in Figure 11 provides information about the difference in temperature in percentage for each component of the IP system between laboratory and field tests. Based on the chart, it can be seen that the difference percentage of the temperature between laboratory and field tests was obtained in the range of 18.2 % to 42.4 %. The highest temperature difference was observed on the center switch with a percentage of 42.4 %. In the meantime, the lowest temperature difference can be observed on IP top surface with a percentage value of 18.2 %. For air outlets on the passenger side, center and driver side, the percentage of temperature differences were 36.7 %, 21.5 % and 39.5 %, respectively. For the rest of the components such as the glove box and IP cover meter combination, the percentage difference was obtained between 27.8 % and 42%, respectively.
