Contaminants on Electrical Contacts Used in Semiconductor Device Testing

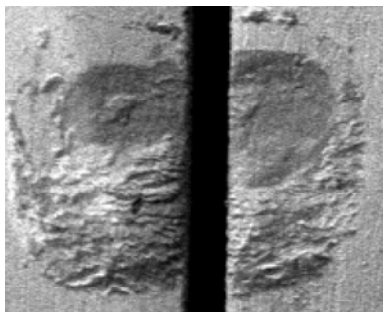
Fig. 2: SEM image of contaminant under 50X magnification

The dark grey part is the contaminants and the light grey part is the uncontaminated surface.

From the SEM images and EDX results, it can be concluded that the contamination is primarily caused by net material transfer as a result of molten metal bridge and electric arc. Further research needs to be carried out to identify the physical factors that directly affect the net mass or volume gain on the electrical contacts. Once the factors are determined, metallurgical solution can be formulated.

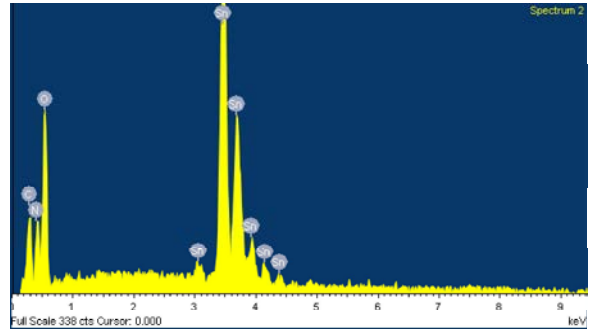
Fig. 3: EDX results of the contaminated surface

Table 1: Material composition of contaminated surface

Element	Weight%	Atomic%
C	5.19	13.71
N	0.65	1.48
O	34.79	68.95
Sn	59.36	15.86
Totals	100.00

As shown in Table 1, the contaminant comprise of high percentage of tin and oxygen. For comparison sake, the following Table 2 shows the material composition of uncontaminated surface.

Results reveal that the contaminant is of high tin content, oxygen elements represents the oxides, indicating that the contaminants contains metal oxides. Carbon elements exist on the surface may originated from the ambient air as studies by Rieder [4] did point out that ambient air is often contaminated with organic vapors. Organic vapors are obviously high carbon content. More than 300 organic vapors were identified in Skylab 4 [5].

The high tin content is obviously originated from the semiconductor device leads which are coated with tin. There are two possible theoretical explanations for the tin transfer from device leads to the electrical contact, namely adhesive wear and metal molten bridge.
