Perforation behaviour of composites sandwich structures on low-velocity impact at oblique angles

ABSTRACT

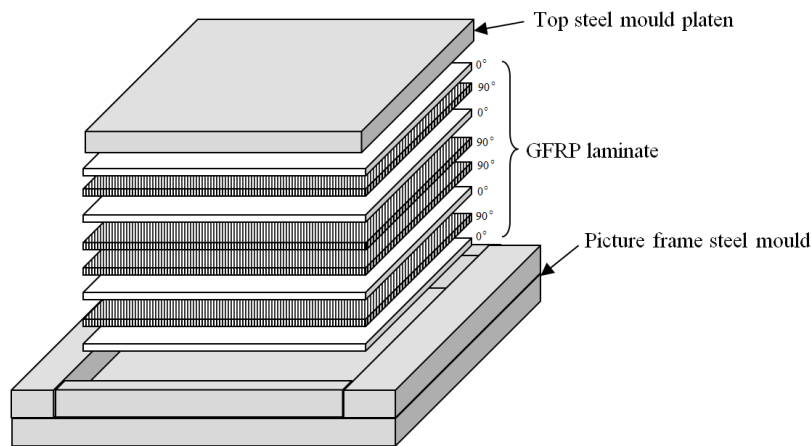
Figure 1. Illustration of the stacking sequence for an 8-ply composite laminate.

The top and bottom skins of the sandwich structures were manufactured in four plies of glass fibre reinforced epoxy with a stacking sequence of [0/90] with a nominal cured thickness of 1.0 mm. The laminates were then placed on either side of the polyethylene terephthalate (PET) polymeric foam core, which is commercially available as AIREX® T92.100. The skin material is commercially available as SE84 unidirectional (E-glass) fibre reinforced epoxy resin prepreg with nominal ply thickness of 0.25 mm. The PET foam core has a nominal apparent density of 115 kg/m^3 and thickness of approximately 20 mm each. The final cured dimensions of the sandwich structures were 150 mm (L) \times 150 mm (W) with a cured thickness of 20 mm. An illustration showing the hand lamination of the sandwich structures is given in Figure 1. The chemical properties of the skin and core materials are given in Tables 1 and 2, respectively.

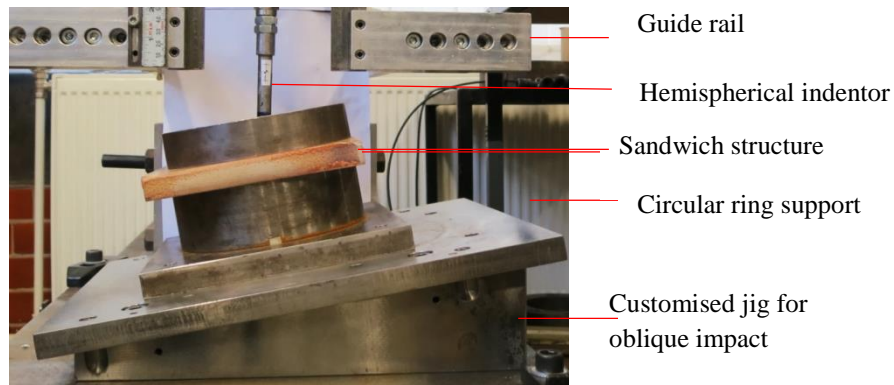
Figure 2. Experimental setup during an oblique impact test on a sandwich structures.

The impact response of the sandwich structures was assessed using an instrumented drop-weight impact rig. Here, a 5.6 kg-carriage of impact mass, with a 12-mm diameter steel hemispherical indenter was used to strike impact energies up to 40 J at normal (0°) and oblique angles of 10° and 20°. The impact velocity measured was at approximately up to 3.78 m/s. A close view of the oblique impact test set-up is shown in Figure 2 with the sandwich panel fully clamped using a 100-mm diameter circular steel ring

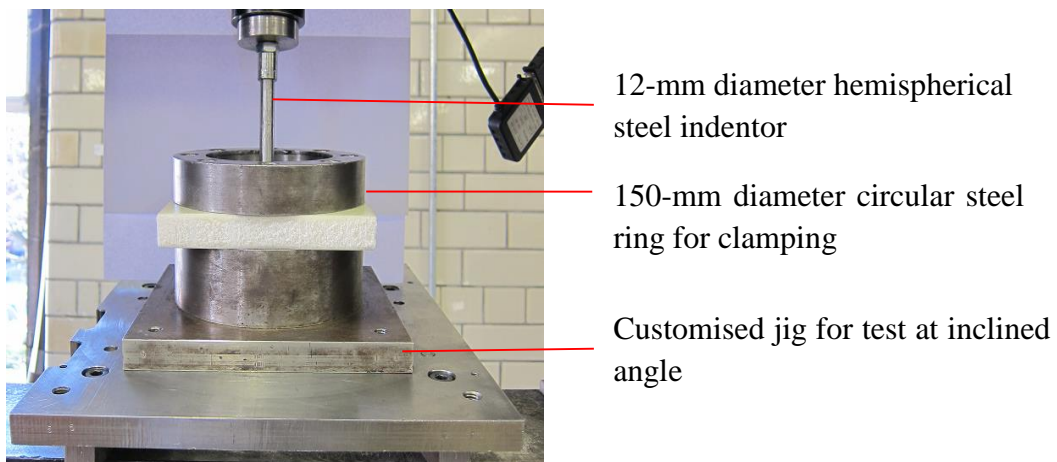
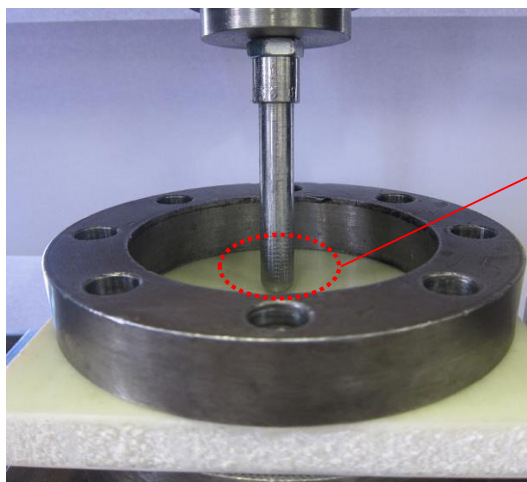
Figure 3 A static indentation test set-up using the oblique impact test rig, showing (a) quasi-static indentation test set-up sandwich panels loaded at 10° of inclination; (b) A closer view showing contact between the hemispherical indenter and the inner surface of the sandwich panel.

A series of indentation tests were carried out using an Instron 4505 test machine at a crosshead displacement rate of 1 mm/minutes under compression loading mode. Like the dynamic loading, the test samples were centrally loaded with similar boundary condition in which the test samples were fully clamped using the same circular steel ring. For tests at inclined angles, a customised jig was used as shown in Figure 3. The working principle of this test was based on the contact law for sandwich structures [22], in which the applied load, P , and the resulting indentation, α , were assumed to obey Meyer's indentation law, which takes the form of the expression in Equation (1) as follows:

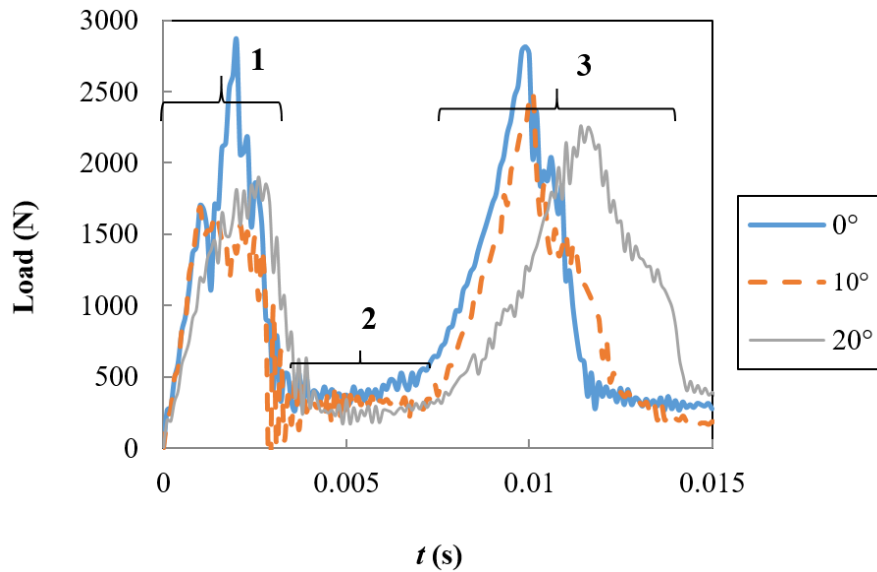
Figure 4. Typical load-time traces following dynamic perforation test (impact test) on the PET (T92.100) sandwich structures with 0°, 10°, and 20° inclination angles.

Examples of typical load-time traces following drop-weight impact at 0° , 10° , and 20° angles are given in Figure 4, whilst detail results are tabulated in Table 3. The plots consist of three main regions; the first peak (1), which is associated with the failure or fracture of the top skin, the second peak (3), which is associated with the failure of the lower skin, and the region in between the two peaks (2), which indicates the average force of the sandwich structures. Clearly, the normal impact response exhibits a much higher force in comparison to that of the non-normal impact cases. Similar observations were reported in an early literature by [2] on low-velocity impact response of normal and oblique impact on composite structures with specific governing equations for the system of forces present during the normal and non-normal or oblique impact. The range of impact velocity for the series of experimental test in the study was up to 5.42 m/s. More recently, Zhou et al. [19] also reported on similar findings following numerical modelling and experimental investigation of the normal and oblique impact on sandwich structures.

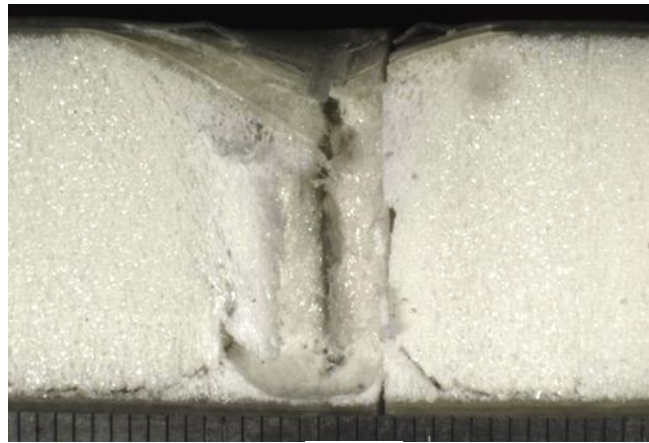
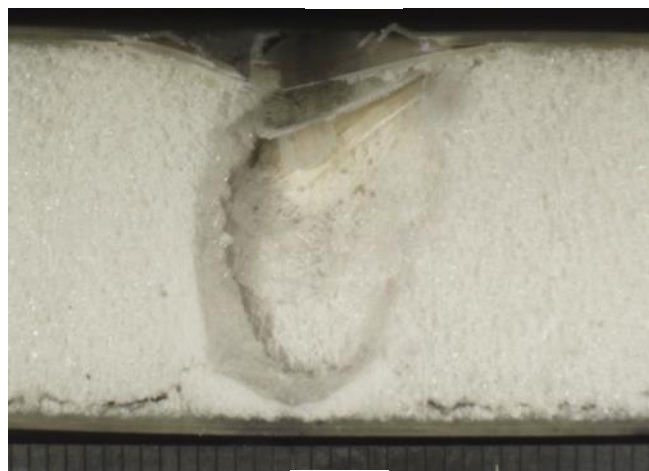
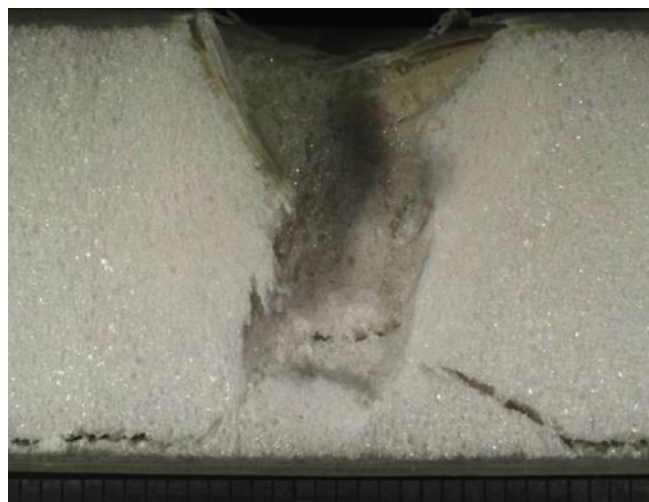
Figure 6. Optical micrographs showing the cross-sections of the PET (T92.100) sandwich structures following quasi-static loading at inclination angles of (a) 0°, (b) 10°, and (c) 20°.

The PET foam core is a rigid polymeric material; therefore, such material is expected to show a more brittle-like failure when subjected to impact loading [24] particularly at higher energies. Figure 6 presents the cross-section result following a series of quasi-static tests on PET (T92.100) foam core sandwich panels supported at inclination angles of 0°, 10°, and 20°. As shown in Figure 6 (a), it was evident that the panel loaded quasi-statically at 0° exhibited both a cylindrical shear zone in the foam core and a tensile cone crack in the top skin. Interestingly, up to a displacement of 25 mm, the indenter did not fully perforate the panel under static loading. In Figure 6 (b), at 10°, it was apparent that the penetrating surface was larger with the shape now being more elliptical and finally at 20°, evidence of significant rear surface damage was apparent as shown in Figure 6 (c).

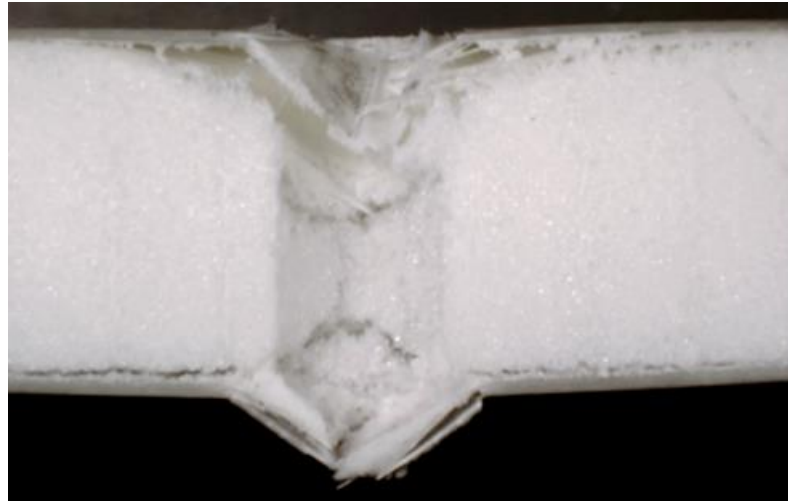
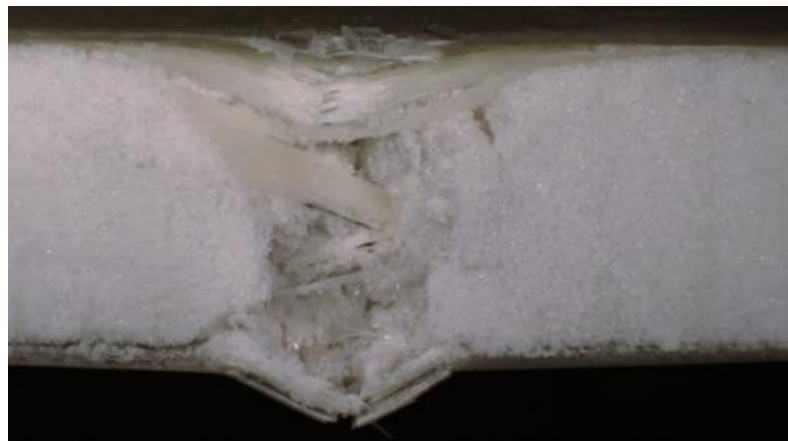
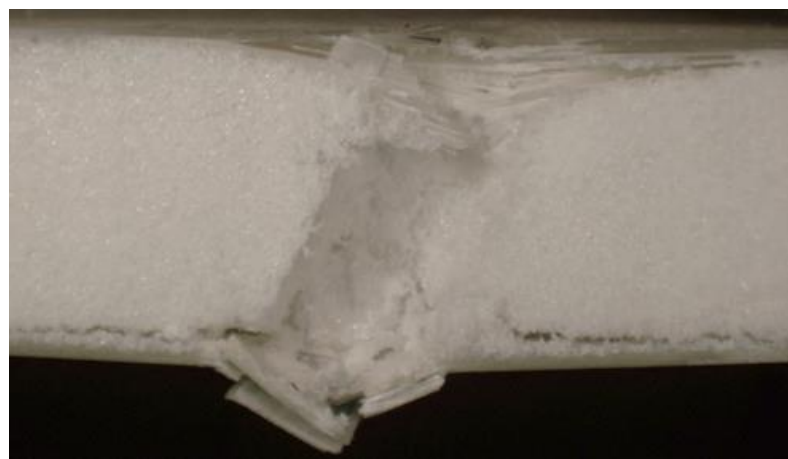
Figure 7. Optical micrographs showing the cross-sections of the PET (T92.100) sandwich structures following impact perforation tests (40 J) at inclination angles of (a) 0°, (b) 10°, and (c) 20°.

Figure 7 presents the corresponding optical micrographs showing the perforation behaviour at the cross-sections. In Figure 7 (a), it was apparent that the sandwich panel subjected to normal impact exhibited tensile failure of the top skin and shearing of the foam core. In addition, the lower skin underwent full perforation and therefore significant tensile fracture of the lower skin was apparent. In Figure 7(b), at 10°, it was apparent that the penetrating surface is larger with the shape now being more elliptical. Finally, at 20°, evidence of significant rear surface damage was apparent as shown in Figure 7(c). These observations can be quantified using a simple geometric analysis, where the ratio of the surface area of an elliptical oblique cylinder to that of a right cylinder in which the projectile creates an elliptical entrance hole on the top surface of the target, as given in Equations (1) and (2). In this work, two cases were considered; i.e., inclination angles of 10° and 20° relative to the normal (θ : 0°). Therefore, considering that r is 6 mm, R is taken as $r \cos(\theta)$, the ratio of the surface area of an elliptic oblique cylinder to that of the right cylinder is given in Table 5. It was apparent that with an increase in inclination angle, the larger surface area was created during perforation of the sandwich panels. For the case of 10°, there was an increase of 1.54 % in terms of the surface area and 2.33 % of the volume. For the case of 20° loading, the increase in surface area was 6.42 % and 9.89 % by volume. These observations further explain the reasons for the increase in the perforation energy, in passing from a normal impact to an oblique impact at an angle of 20°. These observations suggest that perforation at oblique angles allow more materials to be perforated as was reported in the literature [19].
