A CASE STUDY OF OCCUPANT ENVIRONMENTAL COMFORT AT AUTOMOTIVE ASSEMBLY WORKSTATION

¹A.R. Ismail, ²N. Jusoh, ³A.P. Puvanasvaran and ¹M.S. Reza

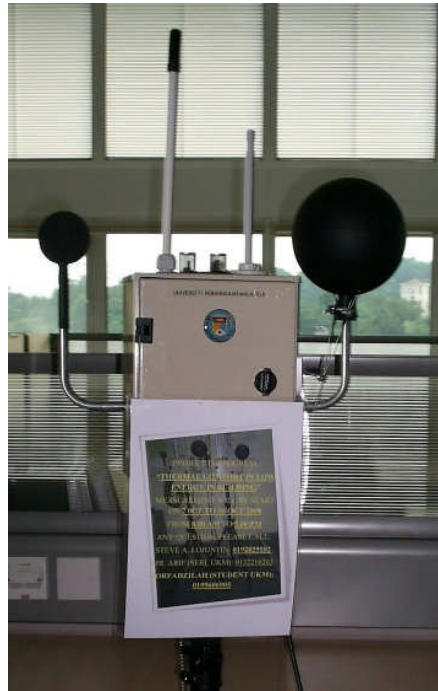
Figure 1: Environment Factors Equipment

By using the Environment Factor Equipment designed by UKM as illustrate as Figure 1, we collect several environmental data for six hours at Final Inspection Workstation. Among the data that we collect using this equipment are carbon dioxide (CO₂) level, pressure, humidity, wind speed, temperature, sound, illumination (lux), and globe temperature. We also match the data with the production output produced by the workers at 10 minutes interval. The data summary of observations by experiment is being represented by the table below:
