An Integrated Cooling Tunnel for Preventing the Breakage of Chocolate Snack Bars

Abstract — Cerealmond Confectionery Sdn Bhd is a manufacturer of chocolate bars in Malaysia. The manufacturer experienced significant yield loss and decreased productivity because of chocolate bars breaking on their manufacturing line. The current industry practice entails a high level of human interaction, which contributes to the occurrence of broken chocolate bars. The project's objective is to eliminate the problem of broken chocolate bars and to increase manufacturer productivity. The analysis determined that the primary issue occurred at the rotating plate, where a thermal imaging camera recorded a temperature of 28.7°C in the rotating plate area, preventing the ingredients from cooling sufficiently to harden. The solution is to maintain a low temperature in the rotating table area, which will quickly harden the chocolate bars and resolve the broken chocolate bar issue. A food-grade cooling tunnel with an acrylic container was designed for the rotating table area, resulting in a temperature of 14.7°C. As a result of the problem being resolved, the process flow was improved, resulting in a threef

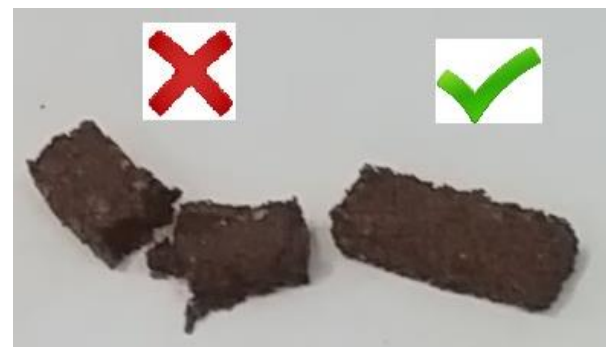
Fig.1 Chocolate snack bar acceptance criteria

definition of breakage of the chocolate bars could be referred to in Fig. 1 and Fig. 2 for reference.

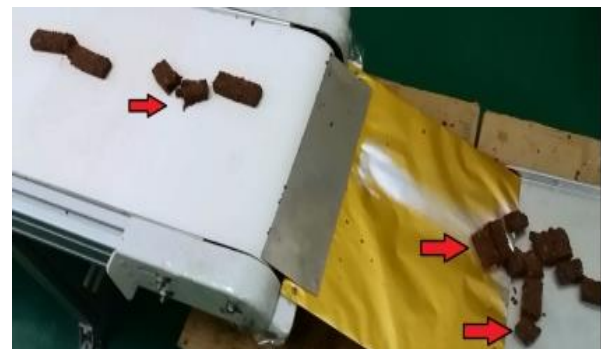
Fig. 2 Breaking snack on a conveyor and pick up tray

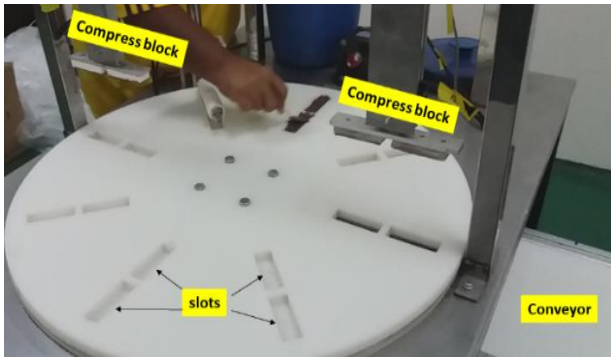
Fig. 3 Rotating plate

The manufacturing process begins with the addition of the chocolate to the rotating plate along with the mixture ingredients. The rotating plate is circular in shape and has sixteen slots for forming the chocolate bars shown in Fig. 3. The purpose of this project is to eliminate the chocolate bar issue and to improve the low UPH manufacturing process that Cerealmond Confectionery Sdn. Bhd. Currently faces. The chocolate bar process flow had been analyzed in order to determine the root cause of the breaking chocolate bar issue.

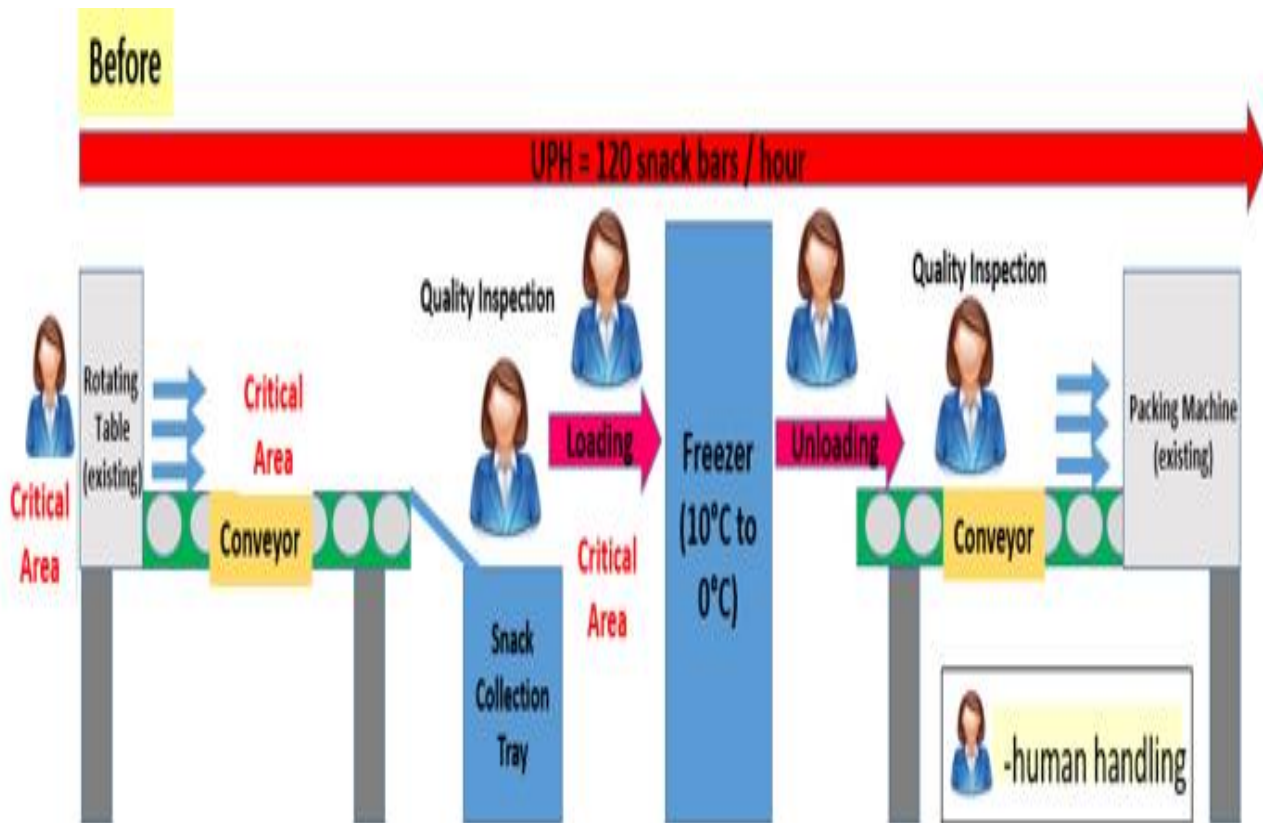
Fig. 4 Existing manufacturing process flow

The chocolate is then compressed in the rotating table slots by the equipment block, and the compressed chocolate bars fall onto the conveyor and then into the collecting tray. The operator will inspect the tray and then manually place it in the freezer for ten minutes to harden. Manual operations involving operators had been mapped as flow diagrams in accordance with Fig. 4.

According to Junchao Lu et al. [3], the traditional method of inspecting finished products is no longer sufficient to meet consumer demand. With current manual practices, the UPH has been impacted, while production costs have increased as a result of the additional inspection process required. Because the company is experiencing a bottleneck, improvement activities are required to increase the UPH and productivity [4,5,6]. Each processing activity, as depicted in Fig. 4, was mapped and analyzed to discover

the primary cause of the problem and the best solution for the company. The critical area for further investigation has been identified as the rotating table, conveyor, and freezer loading process.

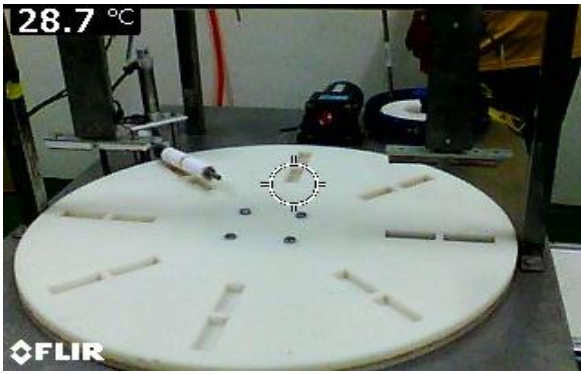
Fig. 5 Rotating plate temperature

Even though the manufacturing area was air-conditioned, the low temperature in the rotating plate area could not be maintained due to the open area. With a rotating plate temperature of 28.7°C, the chocolate ingredients have a low bond to one another, which may result in micro-cracks when compressed by the compressed block. When a microcrack occurs, the chocolate bars will break even if they are placed in the freezer due to the separation that occurs prior to the freezing process. The freezer temperature was maintained between 0°C and 10°C. The team chose to keep the temperature lower in the rotating plate area to allow the chocolate bars to harden in their slots. The idea is to harden it at an early stage, thereby eliminating the need for a freezer and shortening and speeding up the process flow. With a more efficient process flow, the company's productivity (UPH) will increase as well. The evaluation plan may be referred to as Fig. 6.

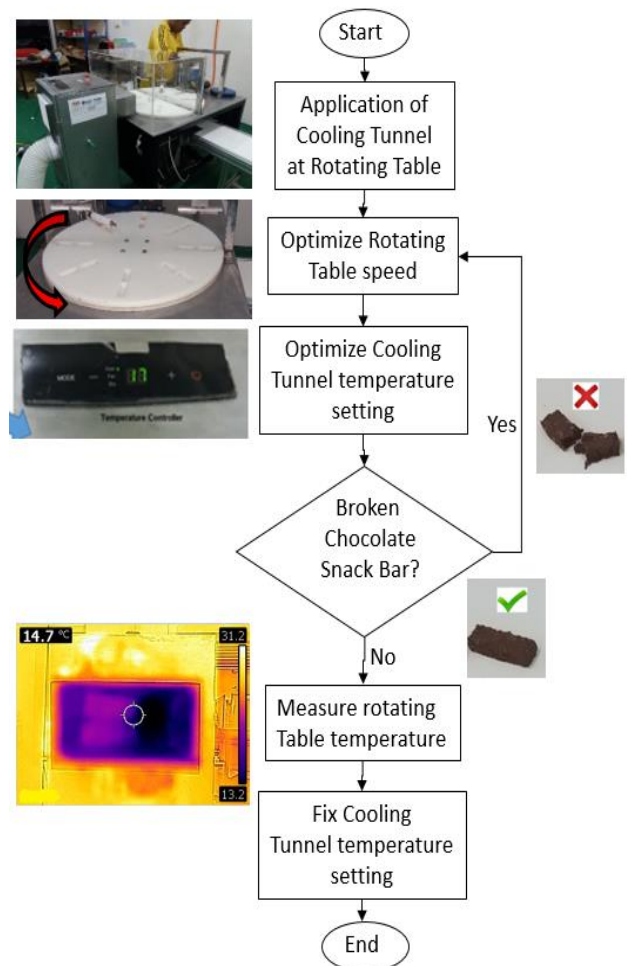
Fig. 6 Evaluation plan process flow

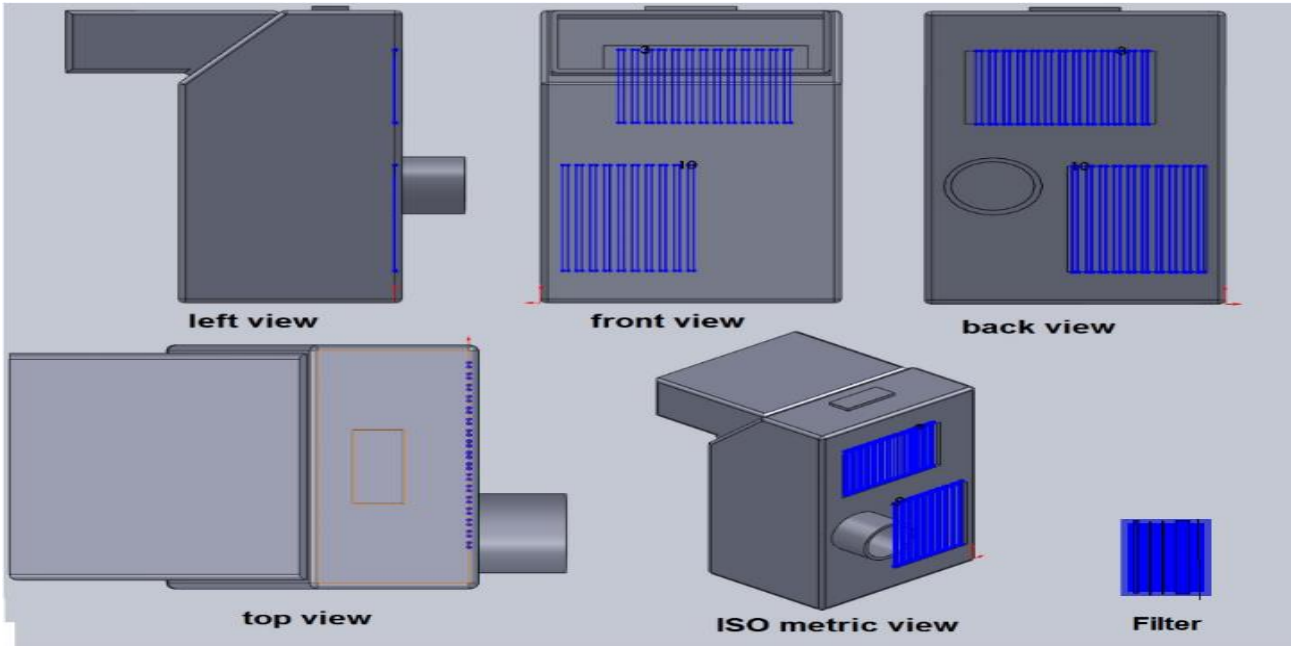
Fig. 7 Cooling tunnel design

The exhaust hose is used to direct hot air away from the chocolate manufacturing area, preventing it from affecting the temperature of the chocolate bars and risking their bonding. The filter is used to ensure that only clean air [20] is directed toward the chocolate bars. The emergency button is located on top of the cooling tunnel to ensure the safety of the process operators. According to Thomas Arnold et al. [21], the emergency red button's purpose is to interrupt a system that has created a threat, thereby minimize the hazards.

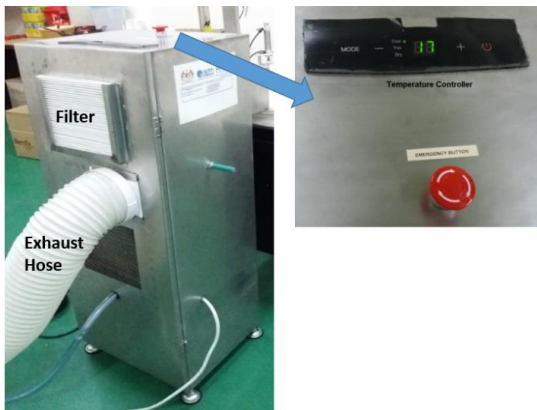
Fig. 8 Actual cooling tunnel

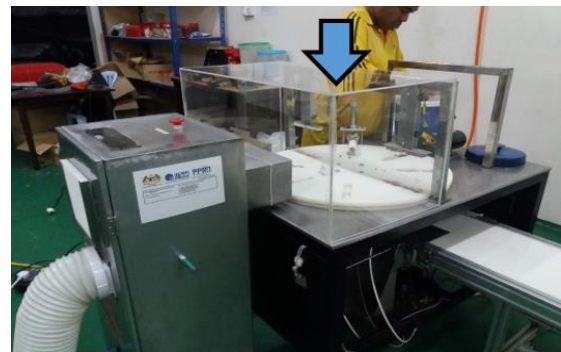
Fig. 9 Acrylic container

chocolate process in the rotating plate, which eliminates the occurrence of broken chocolate bars. The acrylic design shown in Fig. 9 is used to contain the low temperature in the rotating plate area. It is critical to determine whether the acrylic container is necessary to resolve the issue by including it in the DOE as specified in Table 1. The evaluation will compare two conditions: a cooling tunnel with an acrylic container and one without.

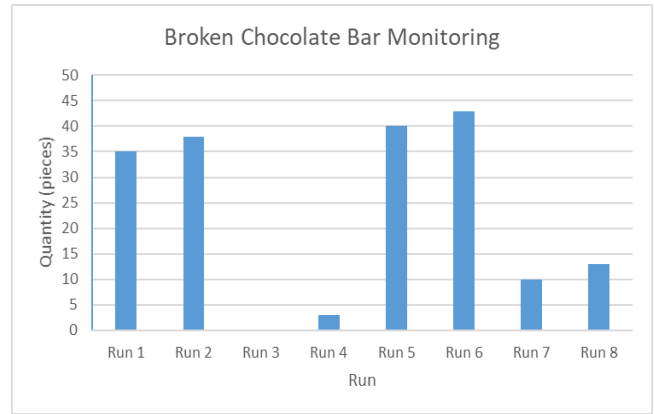
Fig. 10 Monitoring results

A monitoring was conducted to determine the frequency of broken chocolate bars during all engineering runs. Fig. 10 illustrates the overall monitoring results. The monitoring is based on three rotations of the rotating table. One turn of the rotating table produces 16 chocolate bars, and the total evaluation run produces 48 chocolate bars in three turns, as previously stated. The results indicated that in order to achieve a chocolate bar issue-free environment at Cerealmund Confectionery Sdn. Bhd., the conditions in Run 3 should be met. The conditions for Run 3 are as follows: the lowest cooling tunnel temperature of 17°C, an acrylic container, and a minimum table speed of 5 mm/s. Several runs were conducted with this condition setting, and the results demonstrated conclusively that no broken chocolate bar was observed on the conveyor or in the collecting tray in full production mode, as illustrated in Fig. 11.

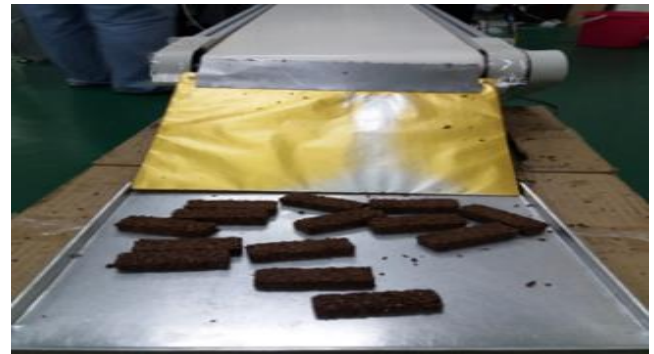
Fig. 11 No broken snack bar on collecting tray

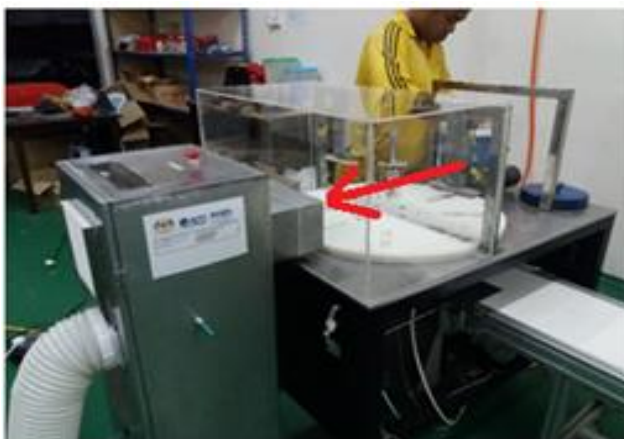
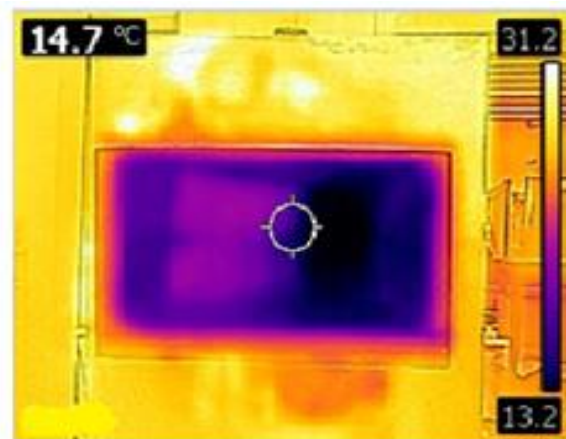
Fig. 12 Cooling tunnel temperature analysis

Additional analysis is being conducted with the use of a thermal camera to determine the real-time temperature with the cooling tunnel and the acrylic container in the run 3 setting. The thermal camera was pointed at the cooling tunnel blower and the results indicated that the temperature was around 14.7 °C in real time, as illustrated in Fig. 12. Due to the absence of broken chocolate bars during the trial run, it can be concluded that temperatures of 14.7 °C or lower can harden the chocolate without causing breakage. Laura stated that the optimal storage temperature for crystalline kinetics was around 15°C [23], and the results corroborated this.

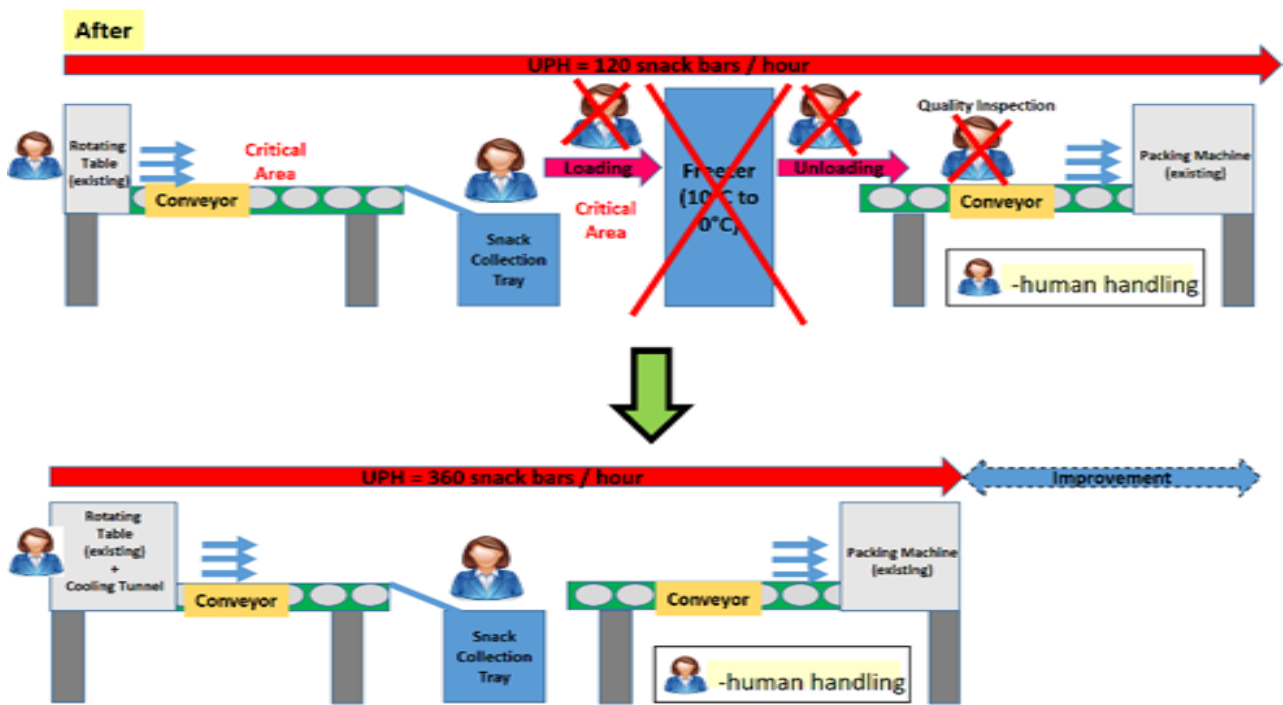
Fig. 13 Improved process flow

UPH will enable users to make more quantifiable and objective judgments about the system's performance [26]. The new process flow began with the addition of a cooling tunnel to the rotating table, followed by a conveyor length reduction to shorten the process time. Due to the fact that the chocolate bars had been hardened previously, the new process did not require the use of a freezer. The new solution avoided the freezer's loading and unloading, which had a substantial influence on UPH performance. Due to the elimination of 60% of the manual operation process, the UPH increased threefold, increasing the existing 120 chocolate bars per hour to 360 chocolate bars per hour. The elimination of the freezer and the loading and unloading process resulted in a reduction in production costs, which clearly benefits the manufacturer in terms of increased profits.
